Risk Management

Insurance Considerations for Magnetic Resonance Imaging Installations

HELMUT RENZ

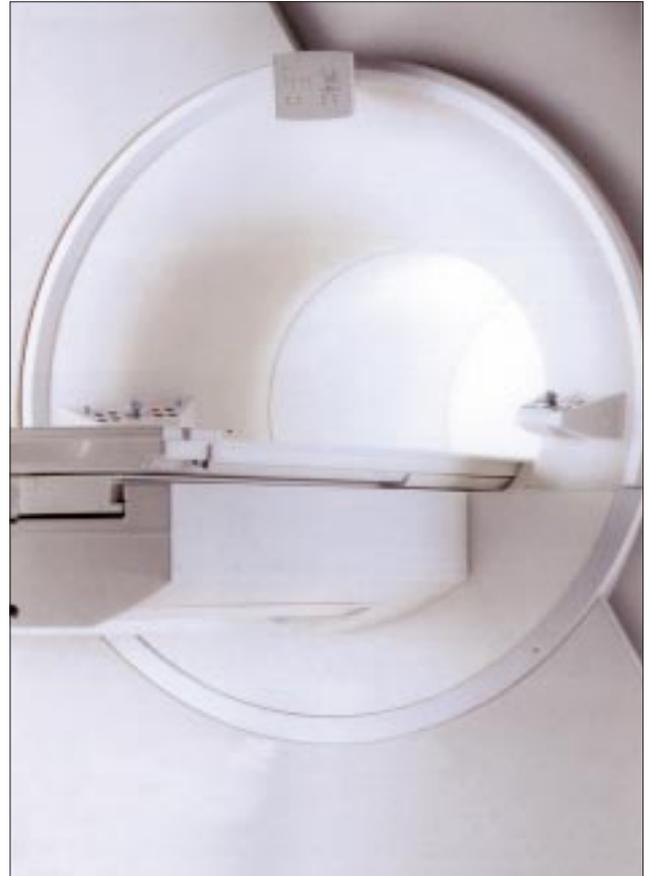
Enormous demands are placed on the apparatus for such examinations. The central part of a magnetic resonance scanner is a large, helium-cooled superconducting electromagnet, which can generate a magnetic field that is many thousand times as strong as the magnetic field of the earth. For this

reason alone, this kind of apparatus must be installed in specially isolated rooms. For safety reasons, no movable metal objects may be allowed near the apparatus when it is in operation, because the magnetic field is strong enough to attract even heavy objects and propel them through the room. The entire system also warms up during operations and must therefore be actively cooled. Finally, a high-performance computer system is also needed to record and analyze the data.
